SUBJECT: Leak Detection and Repair (LDAR) Inspection of Pfizer Pharmaceuticals in Barceloneta, PR

Leak Detection and Repair Inspection Report

Pfizer Pharmaceuticals LLC
Road 2, Km. 58.2
Barceloneta, PR 00617

40 CFR Part 63, Subpart H
AIRS ID: 72-017-00010

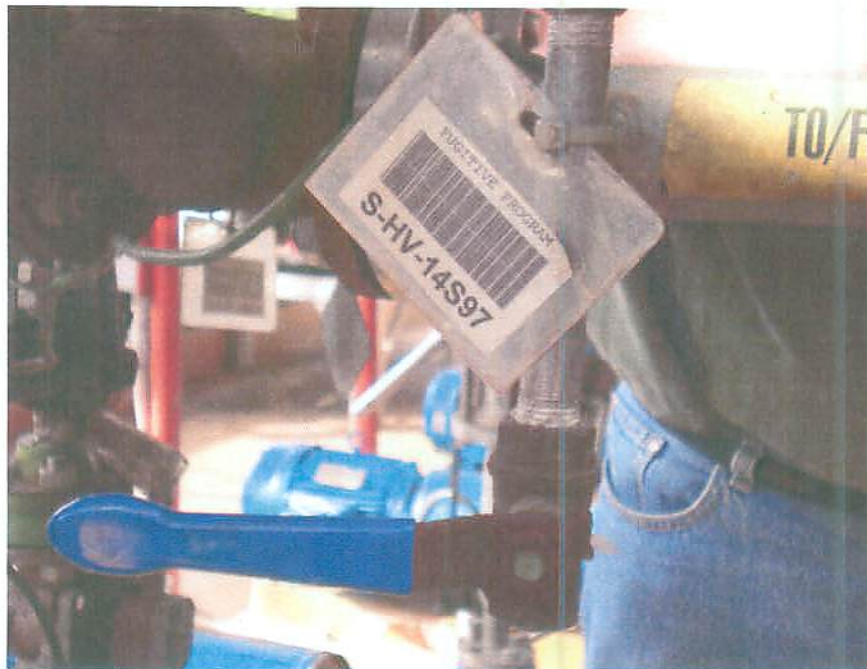
- Region 2 inspectors found 3 Open-Ended Lines (OELs) at Pfizer.

Picture 1: OEL at S-HV-14S97

Pfizer Response: As you know, these open-ended lines were capped immediately during the inspection. The photographs in Attachment III document this activity.

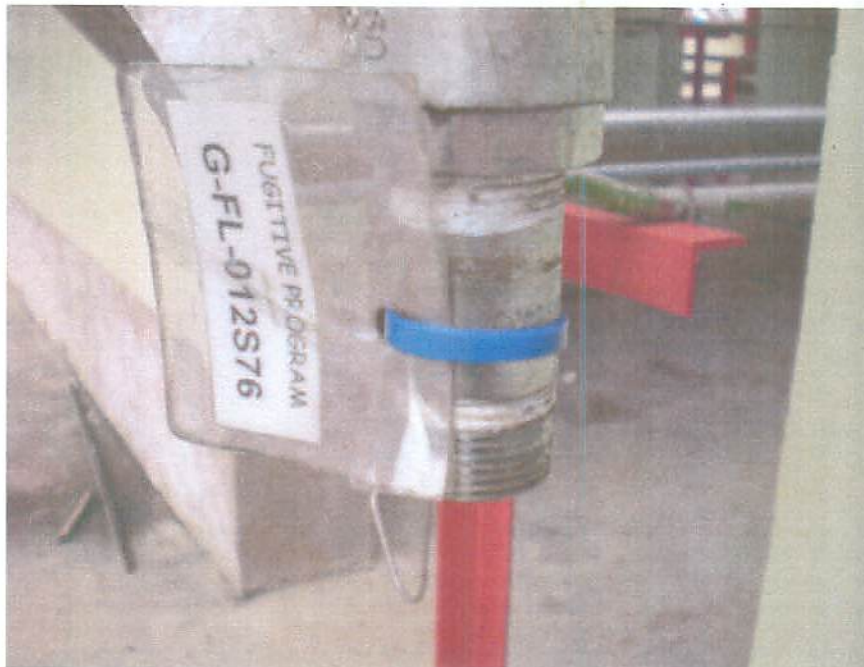
Picture 2: OEL at G-FL-012S76-003
